Injector tip O-ring failure?

November 2008

IPDTB-0017

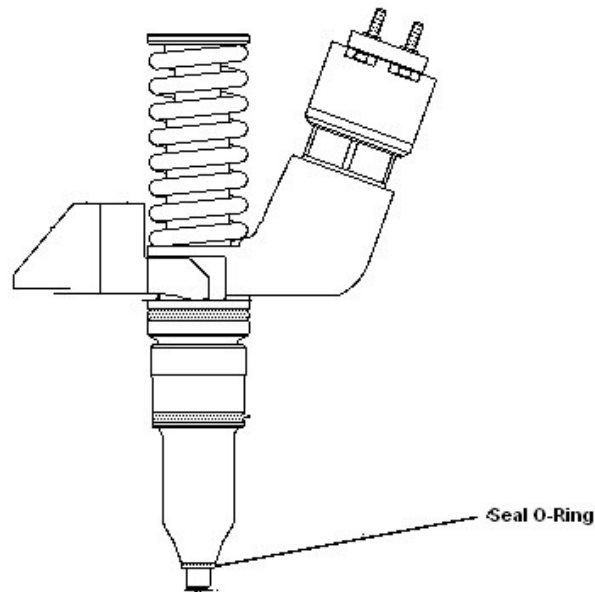
You may have noticed on many of the later model engines, C-15, C-16, C-18, etc. that the seal O-ring at the injector tip has deteriorated. Some have questioned if the O-ring itself had failed and what the effects are.

The function of the seal O-ring at the tip of these injectors is to seal long enough during the break in period for a “carbon dam” to be established. Once the “carbon dam” is in place the seal O-ring has serviced its purpose and due to the harsh conditions associated to this area of the engine the O-ring will deteriorate. This is a normal occurrence and does not affect the engine’s performance or cause the injector to fail.

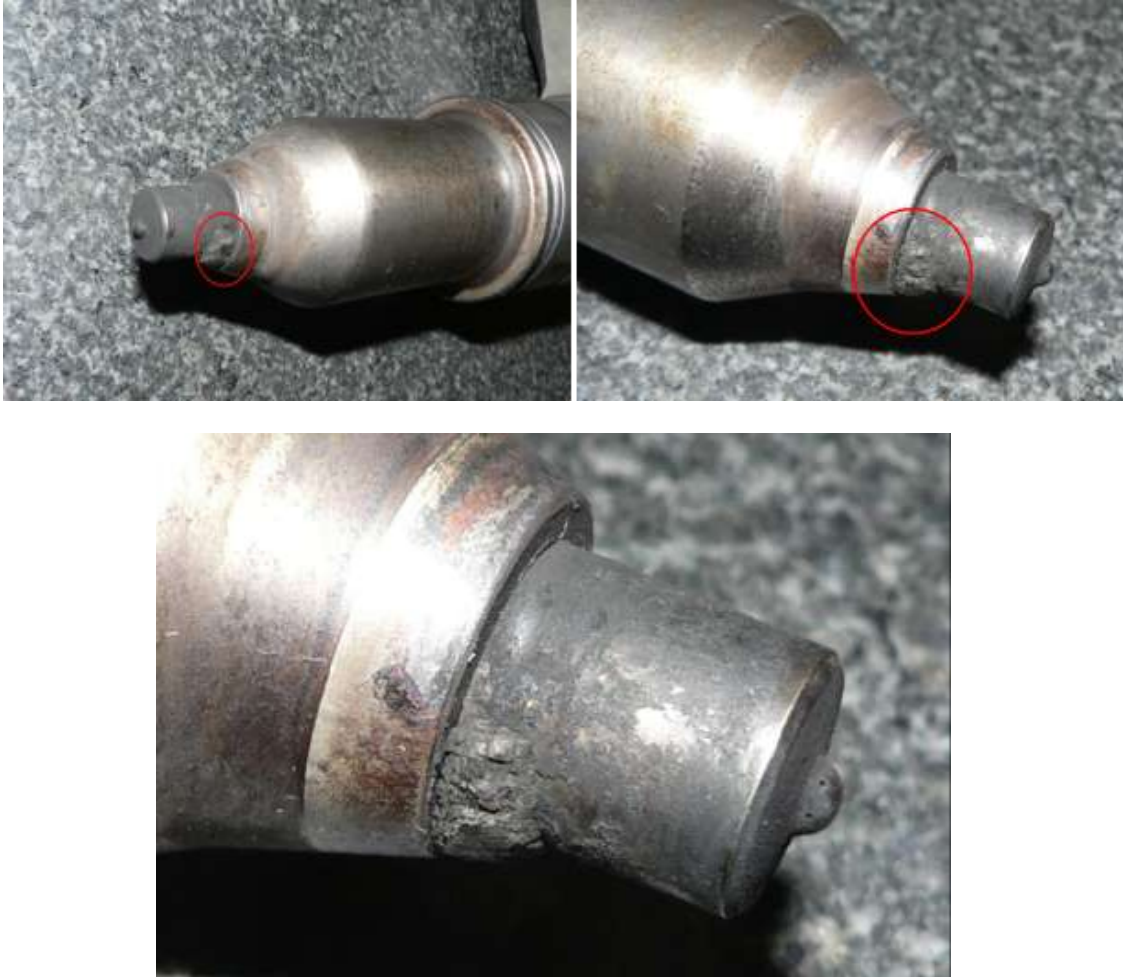
In the photos below you will see the remainder of seal. It is normal for the O-ring to be burnt or damaged during engine operations.
