IPD TECH BULLETIN

IPDTB-0021

Lower Cylinder Block Bores for 3400, C15, & C18 engines

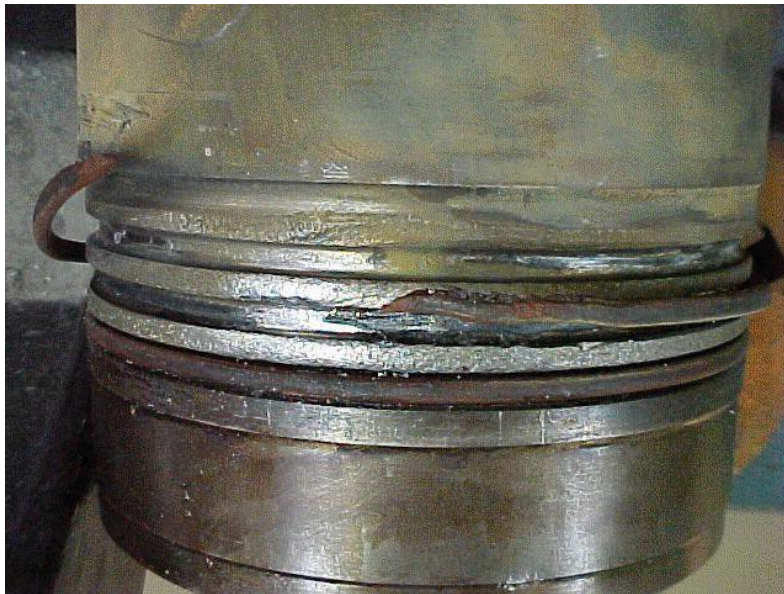
An area on the cylinder block that too often gets overlooked during overhauls is the upper and lower receiver bore areas that supports the cylinder liner. The wear in the photo below is an example of the damage that can result from a worn cylinder block. This cylinder block needs to be repaired prior to installing a new cylinder liner.

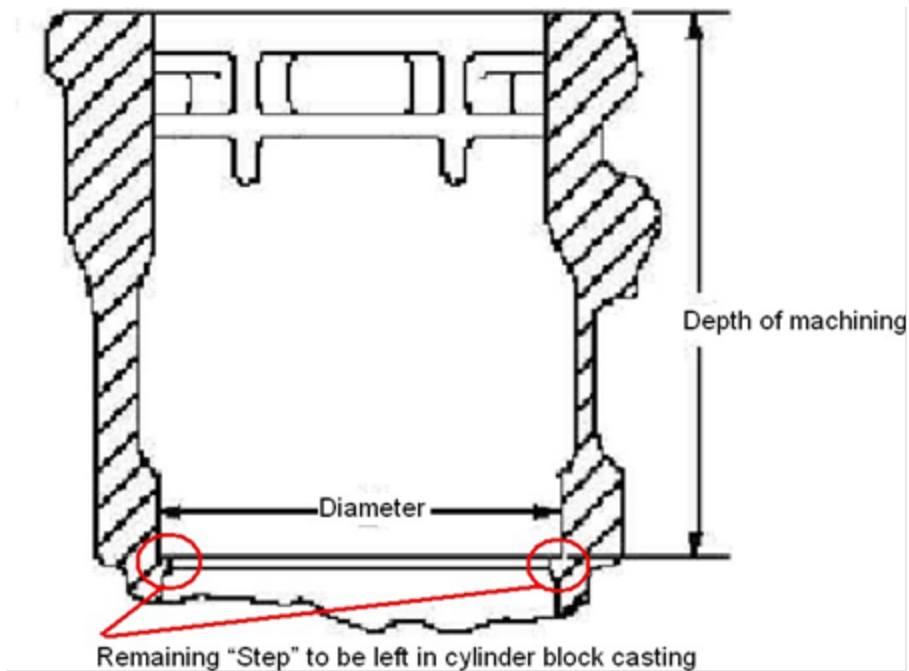
Lower Receiver Bore

The process to repair the lower receiver bore is done with a “step” bore machining technique and a 4W6061 lower repair sleeve. To do this the cylinder block is machined to a specific oversized diameter and to a specific depth to create the proper press fit and a step in the block bore. The “Step”, as shown below helps retain the sleeve and creates a good seal when the sleeve bottoms out against it.

The oversized dimensions to be machined into the cylinder block (shown above) to accept the 4W6061 repair sleeve and create the proper press fit are:

Depth of machining is 8.826 +/- .010" (224.19 +/- 0.25mm)

Diameter is 6.2205 +/- .001" (158.00 +/- 0.025mm)

To install the repair sleeve, the block and sleeve must be clean and dry. Apply high strength Loctite® to the block and freeze the repair sleeve. Install the sleeve with the ID taper upward and hold in place until seated. Allow adequate time for the Loctite® to cure before finish machining.

Finish machining the ID of the installed repair sleeve to 6.059 +/- .002" (153.90 +/- 0.05mm)

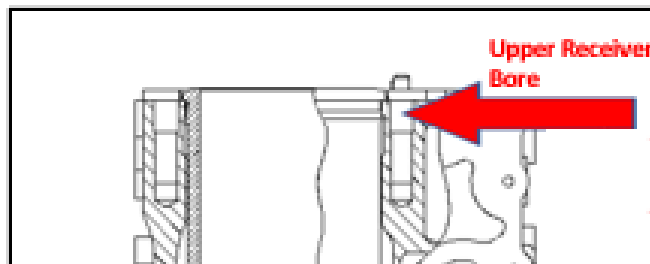
Upper Receiver Bore

OE service information does not publish a diameter spec for this bore. Based on information from our machine shop customers the max diameter is 6.250"

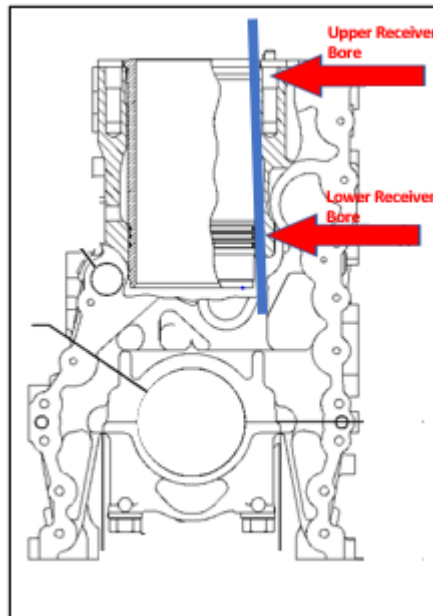
Upper and Lower Bore Concentricity

Another critical dimension that the OE does not publish is the concentricity between the upper and lower receiver bores. Based on information from our machine shop customers the max variance is 0.002"
