Another Surprise Inside Cummins ISX

BY STEVE SCOTT

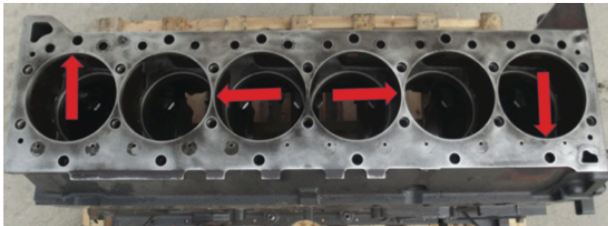
If upper bore erosion is discovered during block inspection, it **must** be disregarded. It is **not** a failure mode and the head gasket provides an adequate seal.

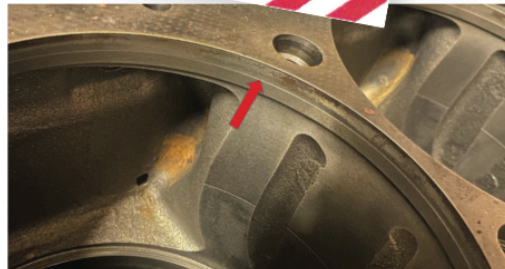
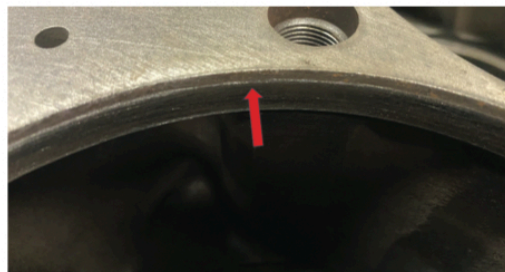
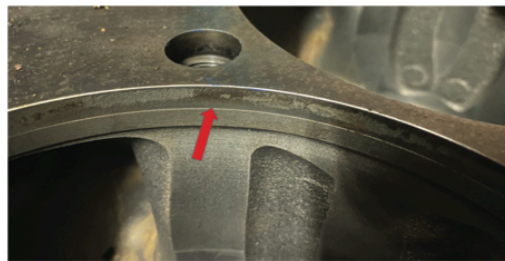
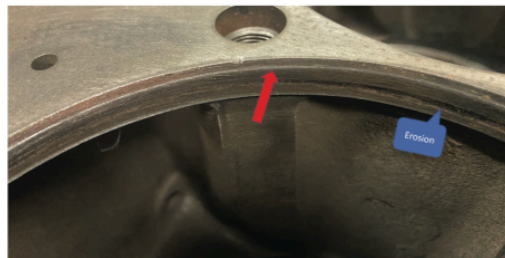
The problem occurs when the upper bore diameter of the block gets worn to the point it cannot hold the liner from moving. The liner movement then causes the head gasket to fret into the surface of the cylinder head and the head gasket to fail.

At the time the OE guide was published, had they not considered the wear these engines would experience? Especially as they age, and the engine experiences the countless number of miles put on these blocks. Pictured far right, these four photos are examples of the wear found around the circumference in the upper receiver bores of a high mileage ISX block.

Examples of wear found around the circumference in the upper receiver bores of a high mileage ISX block.

I have talked to several machine shops and rebuilders about this condition since the last article and have been told this is becoming a more common occurrence. If severe enough, it requires a custom sleeve or insert to be installed in the block to repair the damaged area. When they install a repair sleeve in the block, the rebuilders tend to use a finish bore size of 6.339" to 6.340". Cummins lists a max spec diameter of 6.340" for this upper area of

the liner, but do not publish a spec of the block upper bore diameter. Possibly the movement of the liner or the wear may be seen while the liner is still in the block, but to get an accurate measurement the liners would need to be removed. Without a published spec the acceptable amount of clearance or wear is unknown. A worn diameter of 6.344" tends to be the max diameter for the block according to the rebuilders I spoke with.

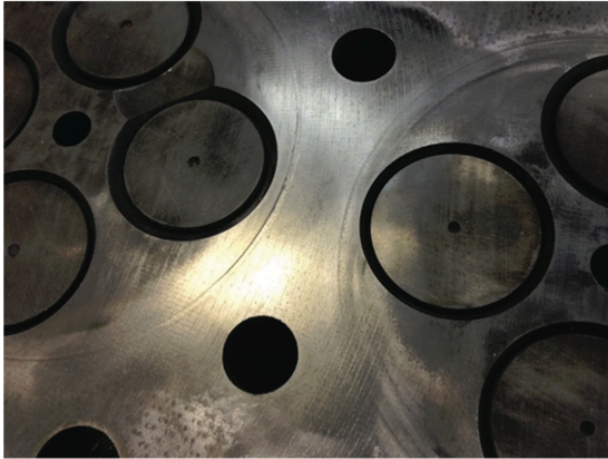
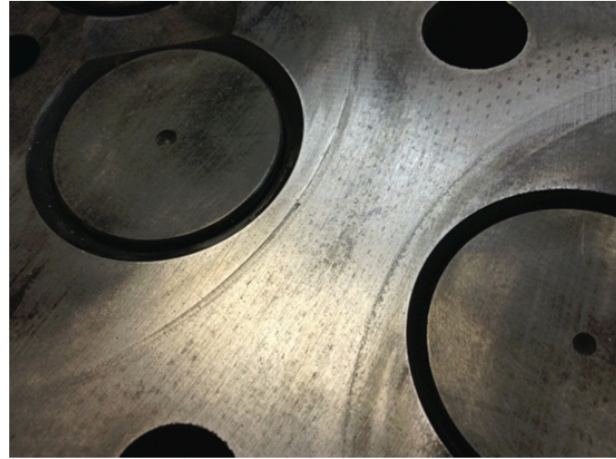
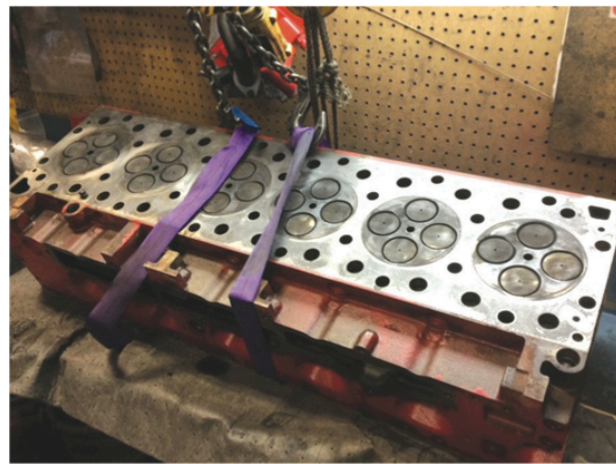
The photos shown here are from an ISX engine that failed the head gasket on two cylinders. There was also fretting damage to the cylinder head on all six cylinders.

When the cylinder liner is not held firmly in place at the top by the cylinder block the liner begins to move with each stroke of the engine. This causes the gasket to fret into the cylinder head, cracking the fire wrap on the head gasket and the gasket soon fails. This is not the gasket’s fault – it has scrubbed against the cylinder head to the point it fails. The clamping force from the cylinder head pushes downward to the lower counter bore in the block and

the top of the liner dances around. The gasket is not designed to withstand this type of movement or force.

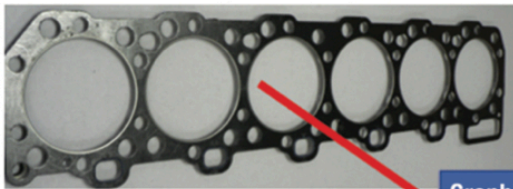
Rough outline of the construction of the head gasket. At each of the cylinders there is a fire wire, or ring incased by the fire wrap. The crushing force from the cylinder head seals this area of the head gasket to the liner.
