## IPD TECH BULLETIN

### *Injector tip O-ring failure?*

November 2008

IPDTB-0017

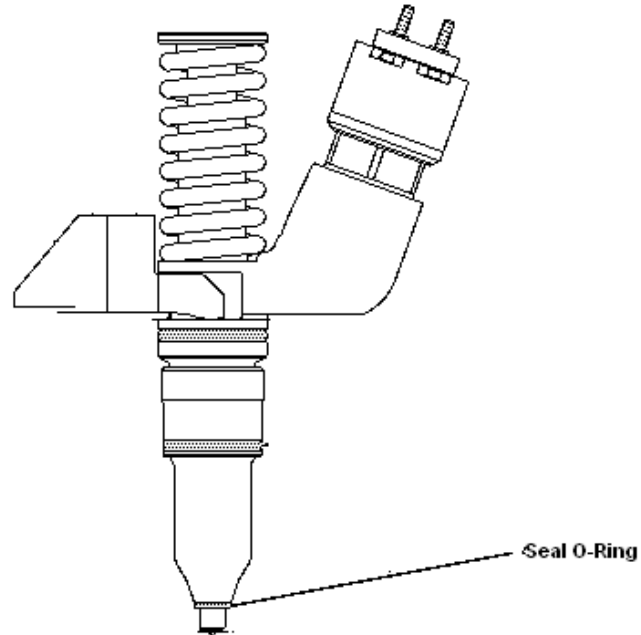
You may have noticed on many of the later model engines, C-15, C-16, C-18, etc. that the seal O-ring at the injector tip has deteriorated. Some have questioned if the O-ring itself had failed and what the effects are.

The function of the seal O-ring at the tip of these injectors is to seal long enough during the break in period for a "carbon dam" to be established. Once the "carbon dam" is in place the seal O-ring has serviced its purpose and due to the harsh conditions associated to this area of the engine the O-ring will deteriorate. This is a normal occurrence and does not affect the engine's performance or cause the injector to fail.

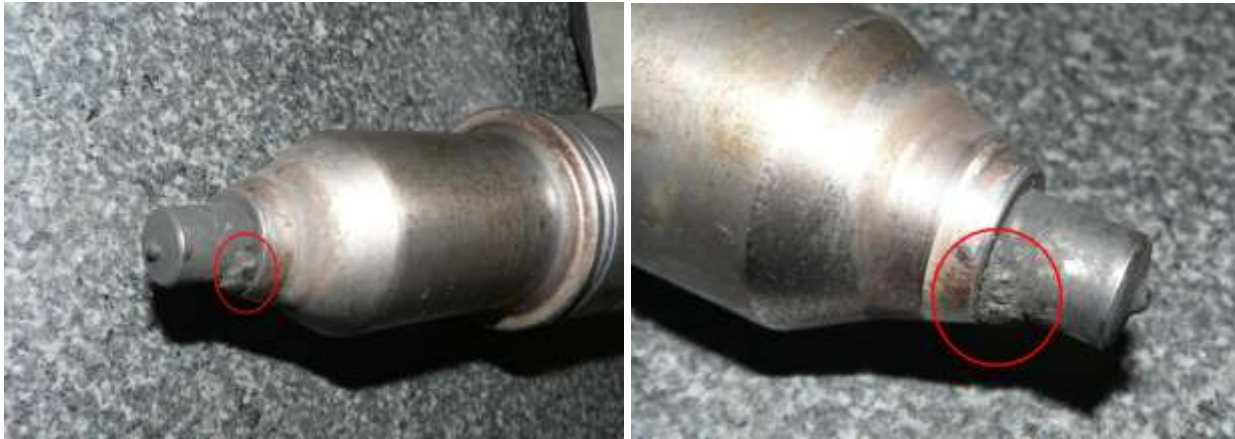
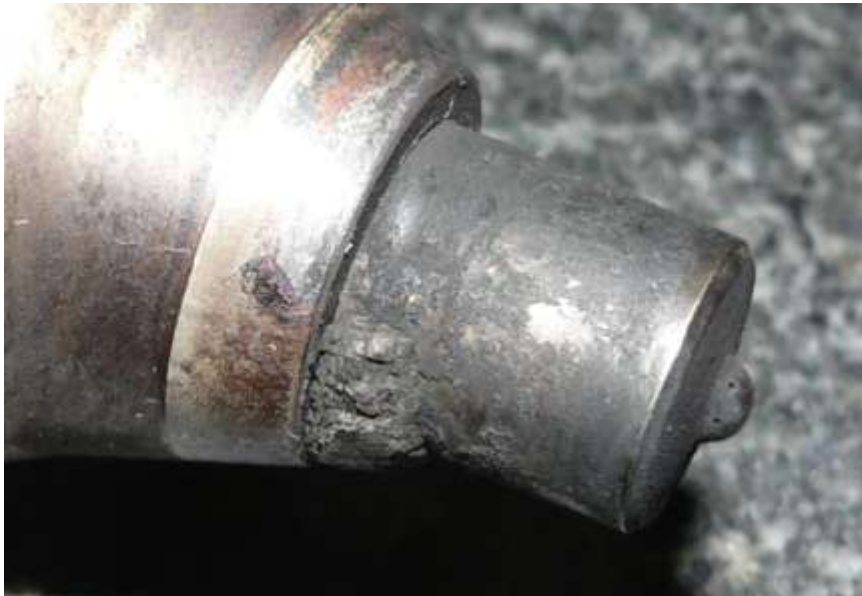
In the photos below you will see the remainder of seal. It is normal for the O-ring to be burnt or damaged during engine operations.
