IPD CHROMOLY STEEL LINER FOR C18/C32 APPLICATIONS

AN IPD INNOVATIVE ENGINEERING SOLUTION

IPD develops an improved liner using a unique material to address a known field issue and proves their new Chromoly Steel Liner, 5560701, works best to keep Caterpillar® engines running.

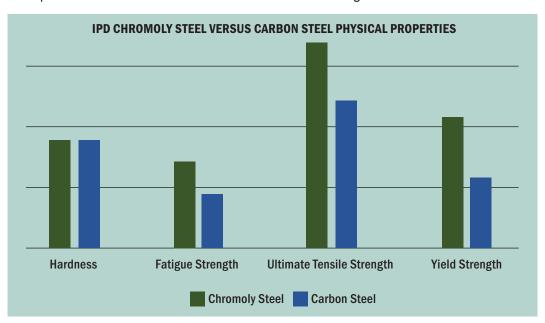
IPD Engineering examined failed field hardware and used computational FEA (Finite Element Analysis) to understand why the crack formed and evaluated potential solutions. The simulation and field data indicated that the initial crack formed after only 10 hours and the larger crack formed by 100 hours of use. IPD tested a few ideas to reduce the stress or eliminate the crack, but the real magic bullet was changing the liner material to a carbon steel that contained added chromium and molybdenum for fatigue strength and toughness. Subsequent multiple successful field tests have resulted in no cracking.

Model Stress Results Crack Prediction

A material change from high carbon steel to chromoly steel has significantly resolved the cracking issue. The C18 liner with chromoly steel does not crack in the upper o-ring groove with the same loading and environmental conditions. The change to chromoly increases the margin of safety and eliminates the fatigue cracks. A steel cylinder liner offers additional strength and ductility over a traditional carbon steel liner. It's simply a better, stronger liner.
