# Cummins ISX Cylinder Liner Dilemma

BY **STEVE SCOTT**

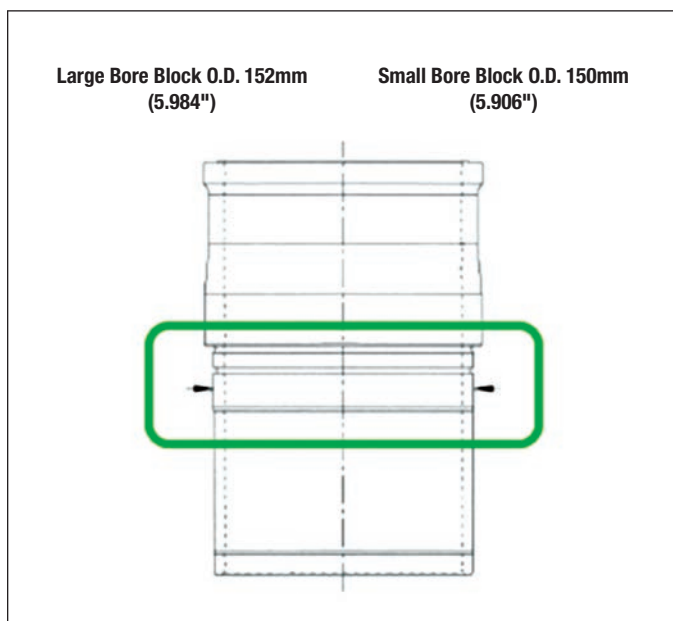
You may not know which cylinder liner is in your ISX until you tear it apart as both 150mm and 152mm cylinder liners were used on Cummins ISX Series engines. The major differences were discussed and charted in the April-July 2017 *Engine Professional* magazine's article entitled, "Continuous Design Changes on the Cummins ISX/QSX Series Cylinder Components". Feedback indicated that there is some confusion or misunderstanding between the 150mm and 152mm liner and counter bore specifications. Some of the confusion may be rooted from the wording found in Cummins literature addressing these as large or small-bore liners and cylinder blocks. Bore size to many readers automatically registers as the cylinder diameter for the piston. However, this is not the case at Cummins with the ISX/QSX engine series. Large and small bore is referring to the outside diameter (OD) of the liner directly below the liner seal and the counter bore (lower receiver) of the cylinder block as shown in the diagram below.

Physically, the 152mm liner will not fit into a cylinder block designed for the 150mm liner, but the 150mm liner can be accidentally (and incorrectly) installed into a 152mm bored block, and that's where the potential for real problems occur. A 150mm liner in a 152mm block will not be supported correctly, and the liner will move from side to side during operation. This

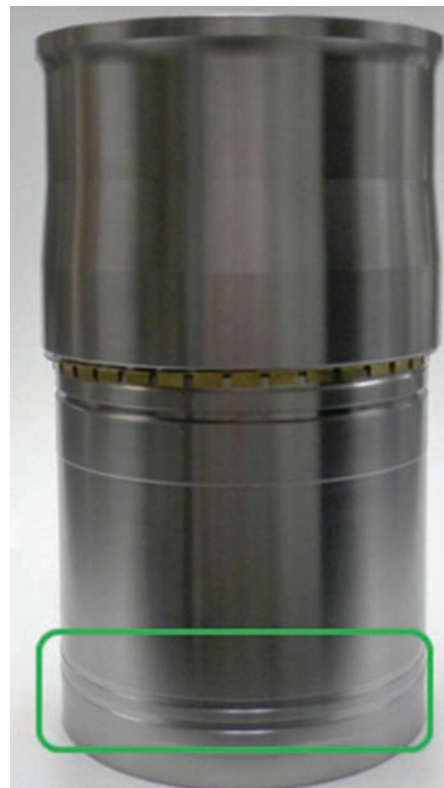
Unfortunately, even with the cylinder head and oil pan removed, there is no way to tell these liners apart while they are installed in the block. There is one groove (band) on the non-APR liner,

and two grooves (bands) on the APR liner that are visible on the outside bottom of each liner that identifies them as being one of the bronze shim designs. Those grooves (shown above) do not identify the diameter of the liner, so, the cylinder block and liner must be measured to assure they are a correct fit.

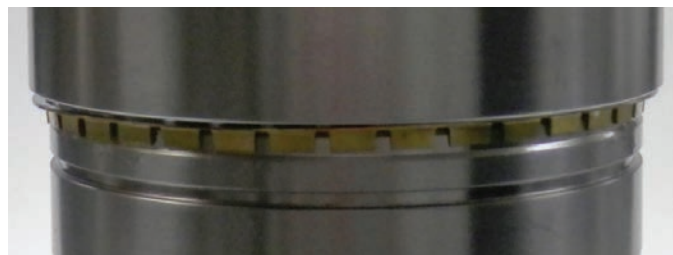
The design of the bronze shims between these liners are also different. The shim for the 150mm liner has tabs that hold it in position on the liner, as shown below. The shim for the 152mm is larger in diameter, and does not have the tabs. The shims are replaceable, but they are not reusable.

The liner seal O-rings are also different diameter for the 150mm and 152mm liners and fortunately they can be identified by their color. The O-ring for the 150mm liner is pink and the

O-ring for the 152mm is blue, without that coloring, they could easily be mixed up.

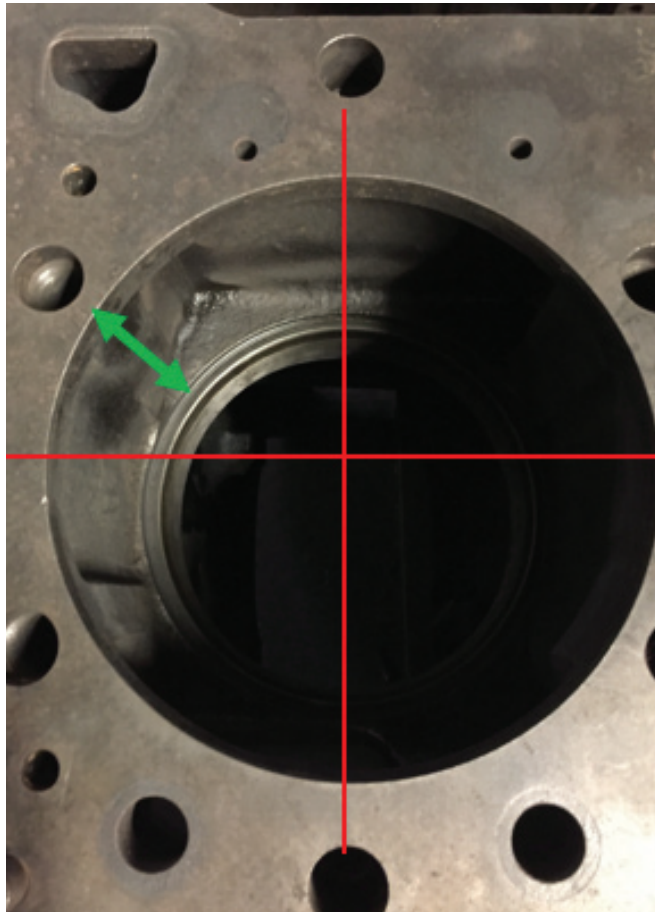
The condition of the surface of the counter bore ledge is also very important. Machining lines should be visible all the way across and around the entire circumference of the ledge. There should not be any areas of fretting or erosion

across the surface, or on the inside or outside of the ledge, as shown below. This ledge (and the dimensions of the liner) are responsible for achieving the correct liner protrusion, and correctly supporting the liner.

Those designs were more susceptible to fretting and wear of the counter bore surface; however, with each successive liner design, the condition of the counter bore continues to be critical to the life of the engine. The OE service publication requires the counter bore depth (distance from the surface of the block deck to the counter bore ledge) to be measured in four locations, and the variance between those four measurements cannot be greater than 0.025mm (0.001”), and the ledge must be flat (level) within 0.0127mm (0.0005”).

If the counter bore height, or if depth variance is greater than is 0.025mm (0.001”) and/or the surface of the counter bore ledge is beyond the reusability guidelines, the block will need to be machined for a repair shim.

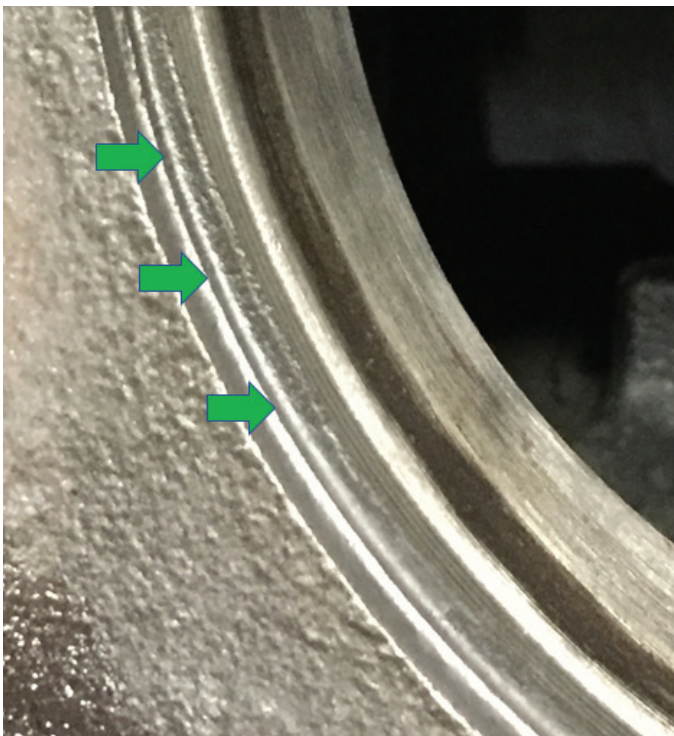
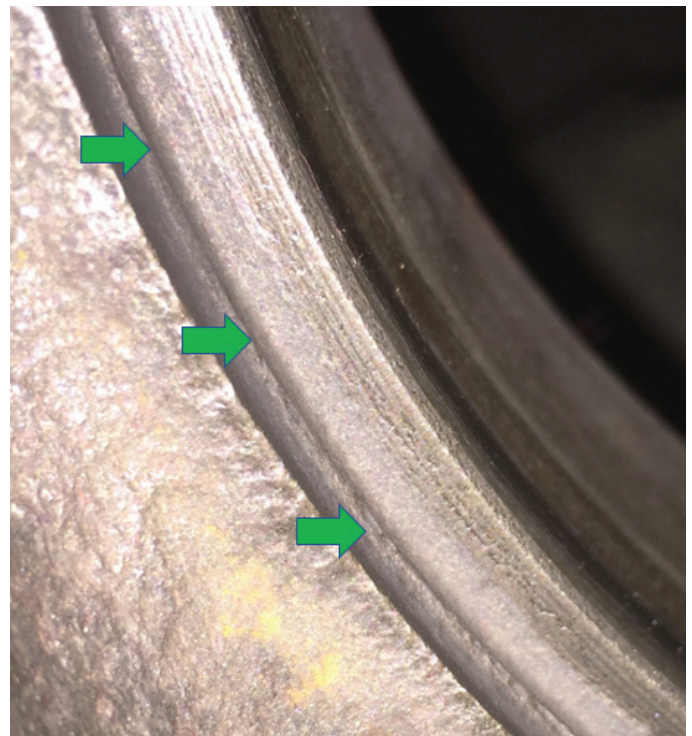
The earlier liner designs did not have a replaceable shim, and the liner rested directly on the counter bore ledge of the cylinder block.
