The Surprise Inside Cummins ISX

BY STEVE SCOTT

This article summarizes the major changes with the following ISX engine components: pistons, liners, connecting rods and bearings, and camshaft (single vs. dual).

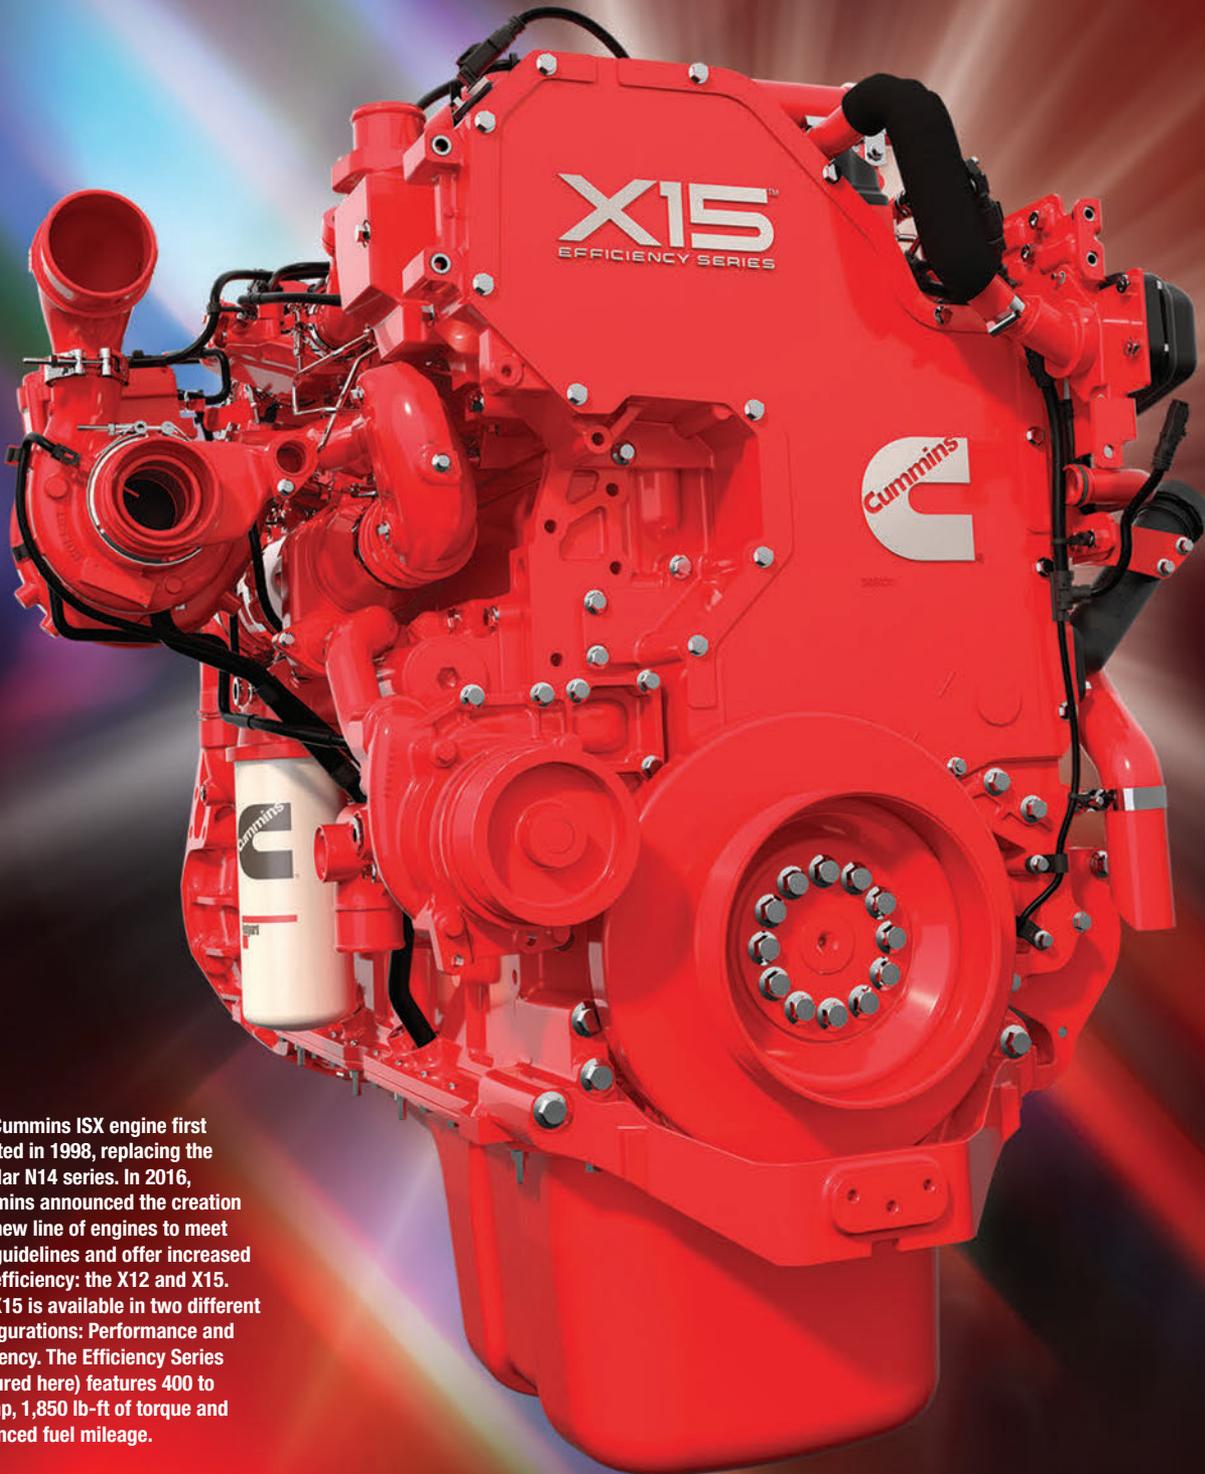
The Cummins ISX engine first debuted in 1998, replacing the popular N14 series. In 2016, Cummins announced the creation of a new line of engines to meet EPA guidelines and offer increased fuel efficiency: the X12 and X15. The X15 is available in two different configurations: Performance and Efficiency. The Efficiency Series (pictured here) features 400 to 500 hp, 1,850 lb-ft of torque and enhanced fuel mileage.

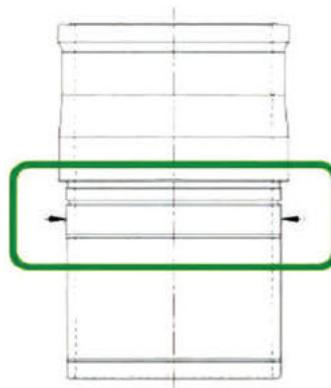
Large bore block OD 5.984" (152mm)
Small bore block OD 5.906" (150mm)

Two grooves on outside bottom of APR liner.

Even with the cylinder head and oil pan removed, there is no way to tell these liners apart while they are installed in the block. There is one groove (band) on the non-APR liner, and two grooves (bands) on the APR liner that are visible on the outside bottom of each liner that identifies them as being one of the bronze shim designs, but these grooves do not identify the diameter of the liner. The cylinder block and liner must be measured to assure they are a correct fit.

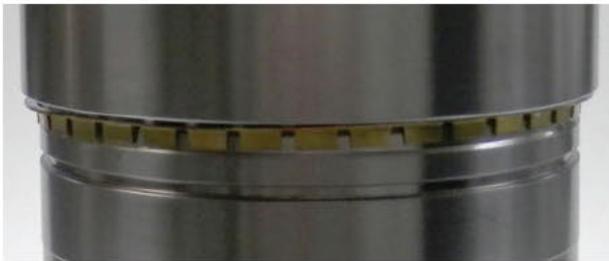
The design of the bronze shims between these liners are also different. The shim for the 150mm liner has tabs that hold it in position on the liner, as show below. The shim for the 152mm is larger in diameter and does not have the tabs. The shims are replaceable, but they are not reusable.

The liner seal O-rings are also different diameter for the 150mm and 152mm liners, but they can be identified by their color. The O-ring for the 150mm liner is pink, and the O-ring for the 152mm is blue.

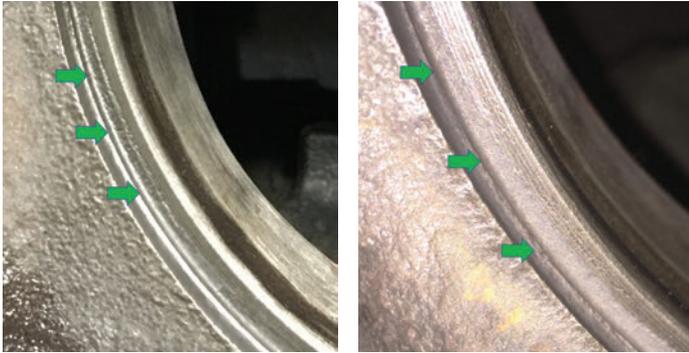
important. Machining lines should be visible all the way across and around the entire circumference of the ledge. There should not be any areas of fretting or erosion across the surface, or on the inside or outside of the ledge, as shown below. This ledge (and the dimensions of the liner) is responsible for achieving the correct liner protrusion, and correctly supporting the liner.

If the counter bore height, or if depth variance is greater than is 0.025mm (0.001") and/or the surface of the counter bore ledge is beyond the reusability guidelines, the block will need to be machined for a repair shim.

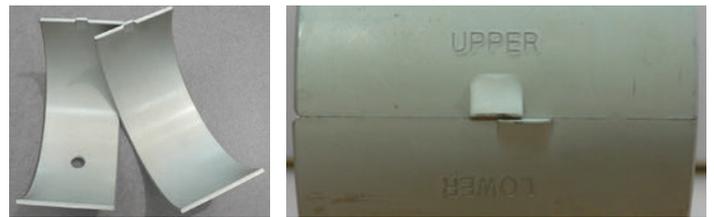
The connecting rod bearings (big end) for the saw cut rods are made up of an upper and lower shell. The shells are marked as to their locations and have alignment tabs that are slightly offset. Be careful, this design does leave room for error. In most cases where upper and lower shells are involved, the alignment tabs are designed so that the shells cannot be installed incorrectly. In the ISX saw cut connecting rods, the tabs on the bearing shells are only offset approx. 2.89mm (.114").

Although it is noticeable if the shells are installed incorrectly, the connecting rod can be installed with the bearing shells in the wrong location. There is enough clearance that the rod can be bolted in place to the crankshaft. If this happens, the engine is destined to fail. The bearing will wear on the fillet radius of the crankshaft. Since the lower shell (which is now in the upper position) does not have the oil supply hole in it, then the connecting rod bushing (small end) and piston pin connection fails due to the lack of an oil supply.

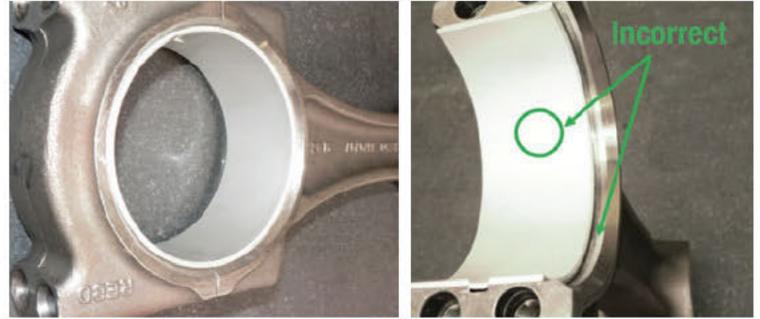
Bearing Installed Incorrectly – the oil port is blocked and the bearing is not evenly centered in the rod.

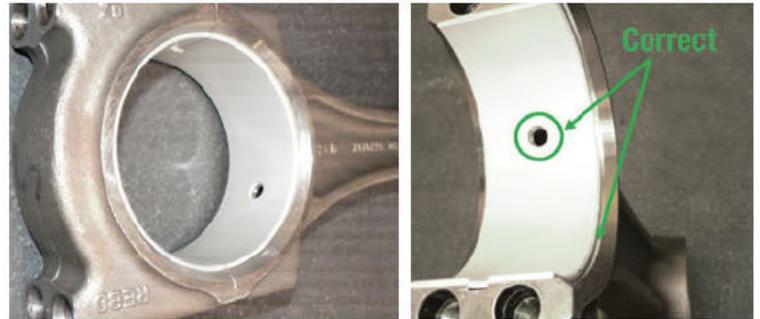
Bearing Installed Correctly – the oil port is open and the bearing is evenly centered in the rod.

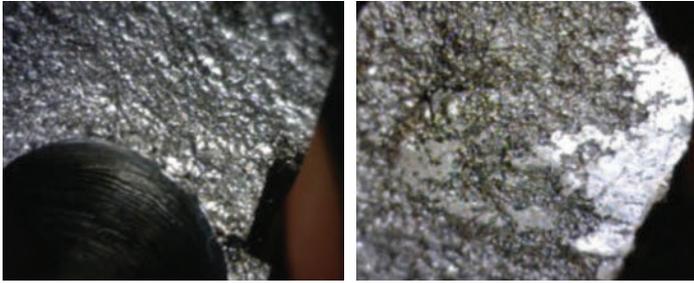
The bearings for the fractured rods also have an upper and lower shell, but the tab design prevents them from being installed incorrectly. The bore diameter (big end) of the fractured connecting rod is larger and the wall thickness of the fractured bearing is thicker, so there is chance of installing them into a saw cut rod.

A fractured rod can be identified by the small hole on the bottom of the rod cap. A saw cut rod does not have a hole in the cap.

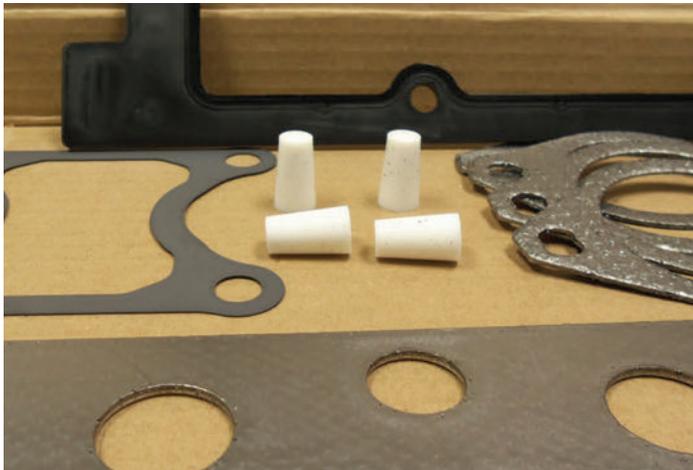
Statistics show that debris (dirt) is the number one cause of bearing failure, which brings us to the first simple precaution. To those not familiar with the ISX engines, the presence of small plugs in the engine and gasket kits may seem odd or perplexing. If the technician does not know their purpose, and/or if discovered after the engine repair, this can lead to confusion.

Over the years, Cummins has had various service campaigns and literature stressing the importance of using these plugs during repairs on ISX engines. Sadly, these plugs are often overlooked.

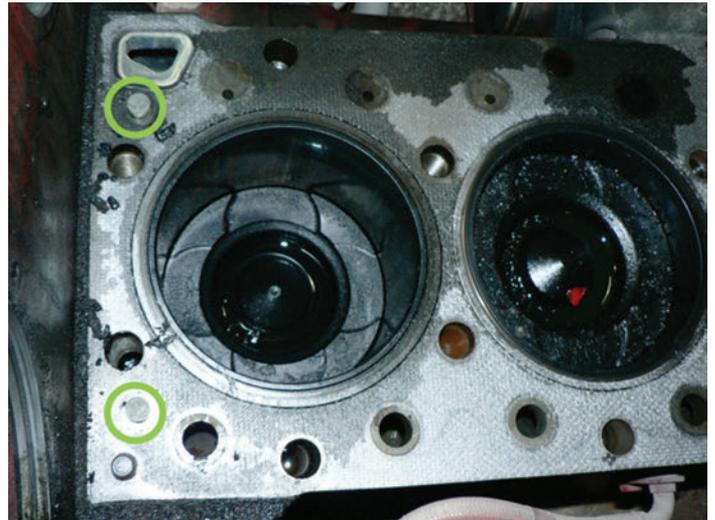
Below is a photo of the front of an ISX block with the plugs (circled in green) installed in the oil ports.

The purpose of these plugs is to temporarily block off the oil ports, thus keeping debris out of the engine while it is being repaired. On the ISX engine, there are almost straight ports from the lower bearings to the upper bushings in each corner of the cylinder block and head. After the cylinder head is removed, these ports become open pathways for debris to enter straight down into the lower oil passages of the engine.

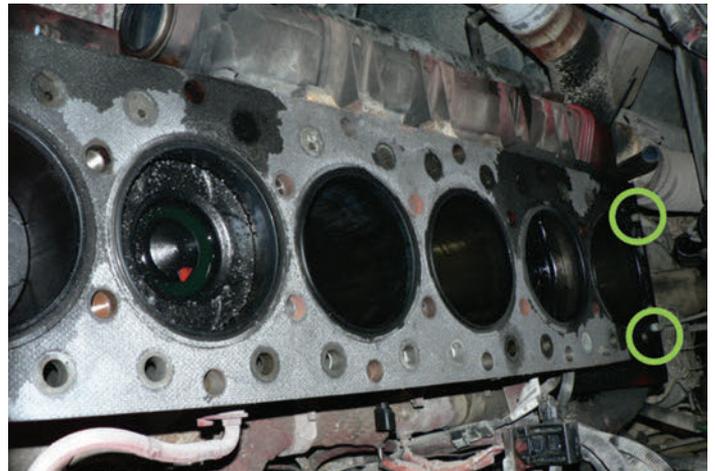
There are two additional ports at the back of the block.

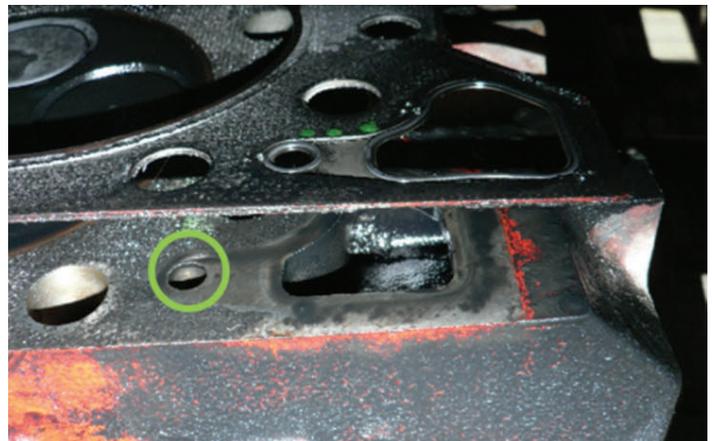
Plugging the ports in each corner of the cylinder head is also important, since debris entering these ports can go directly into the cam and upper bushings.

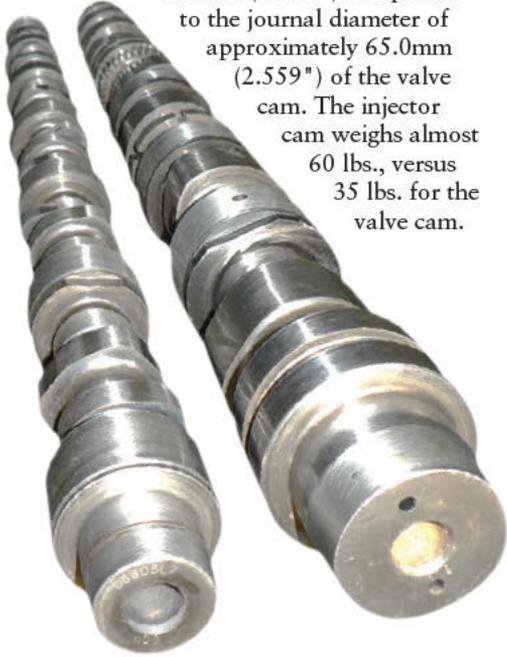
The injector camshaft and bushings on the earlier dual cam engines is massive in comparison to the valve camshaft, with a journal diameter of approximately 85.0mm (3.346") compared to the journal diameter of approximately 65.0mm (2.559") of the valve cam. The injector cam weighs almost 60 lbs., versus 35 lbs. for the valve cam.

While it may be common practice to drive the camshaft bushing in for other engines, Cummins installation instructions indicate that the cam bushings (injector and valve) are to be pressed in (not driven). Several cylinder head rebuilders have reported that they are convinced that due to the size and amount of retention (crush) holding the injector cam bushings in place, they cannot be driven in without distorting or damaging the bushing, resulting in bushing failures.
