Another Surprise Inside Cummins ISX

BY STEVE SCOTT

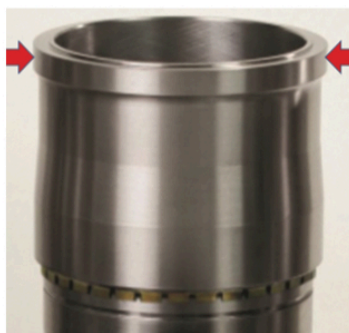
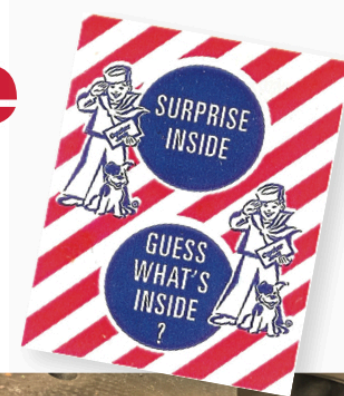
The problem occurs when the upper bore diameter of the block gets worn to the point it cannot hold the liner from moving. The liner movement then causes the head gasket to fret into the surface of the cylinder head and the head gasket to fail.

At the time the OE guide was published, had they not considered the wear these engines would experience? Especially as they age, and the engine experiences the countless number of miles put on these blocks. Pictured far right, these four photos are examples of the wear found around the circumference in the upper receiver bores of a high mileage ISX block.

Examples of wear found around the circumference in the upper receiver bores of a high mileage ISX block.

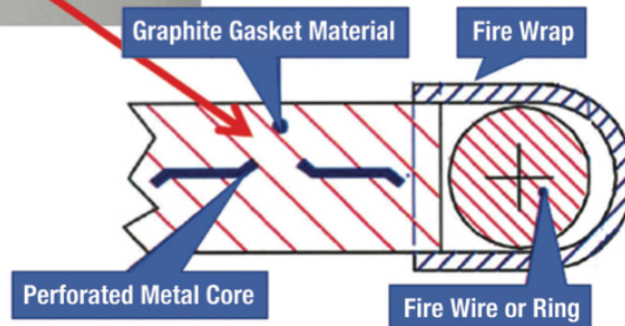
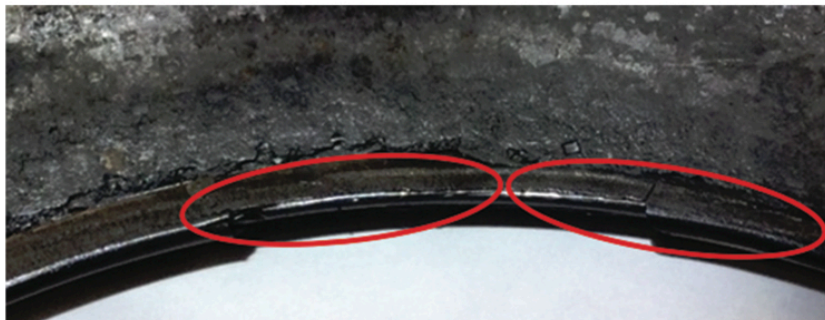
The photos shown here are from an ISX engine that failed the head gasket on two cylinders. There was also fretting damage to the cylinder head on all six cylinders.

When the cylinder liner is not held firmly in place at the top by the cylinder block the liner begins to move with each stroke of the engine. This causes the gasket to fret into the cylinder head, cracking the fire wrap on the head gasket and the gasket soon fails. This is not the gasket’s fault – it has scrubbed against the cylinder head to the point it fails. The clamping force from the cylinder head pushes downward to the lower counter bore in the block and

the top of the liner dances around. The gasket is not designed to withstand this type of movement or force.

I have talked to several machine shops and rebuilders about this condition since the last article and have been told this is becoming a more common occurrence. If severe enough, it requires a custom sleeve or insert to be installed in the block to repair the damaged area. When they install a repair sleeve in the block, the rebuilders tend to use a finish bore size of 6.339" to 6.340". Cummins lists a max spec diameter of 6.340" for this upper area of
